SERVICE BULLETIN M20-299

SUBJECT: Mooney M20TN (Acclaim) Aircraft with KELLY AEROSPACE TURBOCHARGER(S)**MODELS/ SN** **M20TN (ACCLAIM):****AFFECTED:** 31-0039, 31-0042, 31-0044, 31-0046, 31-0047, 31-0049, 31-0050, 31-0052, 31-0053, 31-0056, 31-0057**TIME OF COMPLIANCE:** MANDATORY - BEFORE NEXT FLIGHT**INTRODUCTION:** This Service Bulletin is written in conjunction with Teledyne Continental Motors (TCM) Service Bulletin MSB07-4 and Kelly Aerospace Service Bulletins 023 & 027 (Attached). This Service Bulletin is to remove and replace the specified turbocharger(s) (TCM P/N 646677) from Mooney Aircraft M20TN (Acclaim) in accordance with attached TCM/Kelly Aerospace Service Bulletins.**INSTRUCTIONS:** **Read entire procedures before beginning work.**

MSB07-4

SUBJECT: KELLY AEROSPACE POWER SYSTEM'S TURBOCHARGER REPLACEMENT

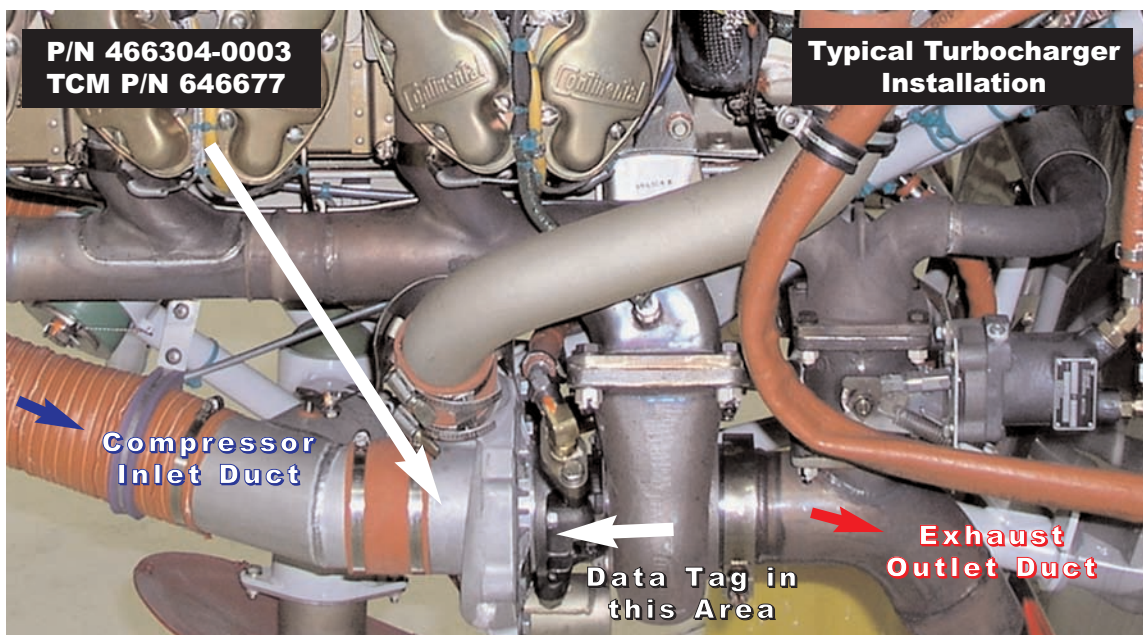
Figure 1 - Turbocharger Installation

It has come to the attention of Kelly Aerospace Power Systems of a disabled turbocharger where the turbine and compressor wheel shaft bearing journals were pushed inward and damaged on a part number 466304-0003 turbocharger. Examination of the damage revealed that a conical vibration along the turbine wheel and shaft assembly was the principal source of the damage. Investigation of the cause has determined that the turbine wheel shaft assembly for this particular turbocharger may have been improperly balanced. Continued operation with a turbine wheel shaft imbalance may result in the separation of the turbine wheel head from the shaft rendering the turbocharger inoperative and may result in the partial or total loss of engine power.

1. Access the aircraft turbochargers in accordance with the instructions in the aircraft maintenance manual.
2. Remove the compressor inlet ducts to expose the compressor wheels (see caution above). Refer to Figure 1.

1. The affected turbocharger P/N 466304-0003 (TCM P/N 646677) must be removed and replaced per the table shown on page 1. Each aircraft has two turbochargers. Check the data tag on each to identify whether the serial number of the turbocharger is one that is affected. When identification is made, remove the turbocharger from the aircraft. Removal must be in accordance with the aircraft and/or engine manufacturers maintenance manuals or service instructions. Contact the aircraft and/or engine manufacturer to determine the disposition of the suspect turbocharger and information regarding the return of the turbocharger(s). All warranty applications must be made through the aircraft and/or engine manufacturer. *Refer to Fig 1 as required.*

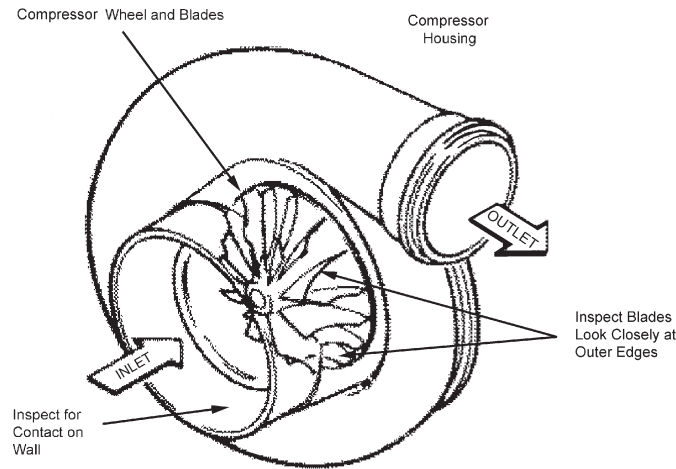
Figure 2 - Turbocharger Inspection Points

3. Visually inspect each turbocharger through the compressor inlet for any signs of contact. Look for witness marks from the impeller wheel, giving careful attention to the outer edges of the wheel blades and the inner wall of the compressor housing. Contact marks on the housing from the wheel will appear as a burnishing on the inner wall. Grooves or gouges of any sort are cause for turbocharger replacement. Utilize supplemental lighting if needed to facilitate visual inspection. Refer to Figure 2, page 3.

4. If any anomalies are noted during the visual inspection, replace the turbocharger. If nothing appears in the visual inspection, the turbocharger is suitable to submit for a ferry permit. This will allow the aircraft to be relocated to qualified facility for turbocharger replacement.
